AVIATION INVESTIGATION REPORT

A05A0155

COLLISION WITH WATER

MBB BO105 (HELICOPTER) C-GGGC

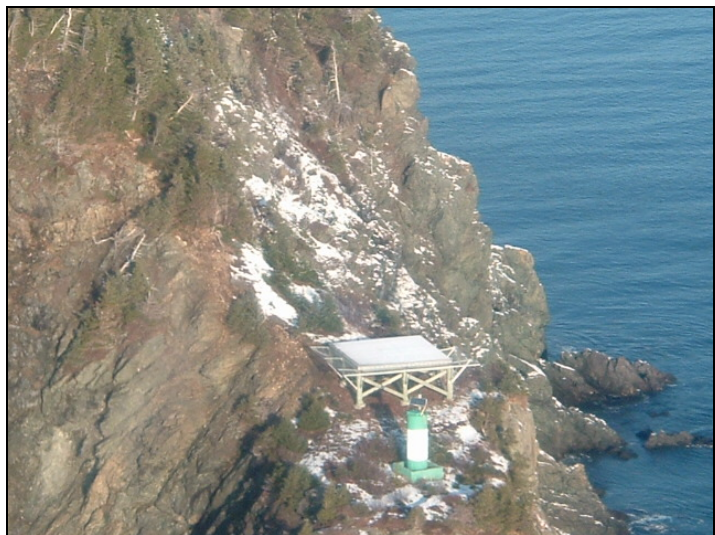
Photo 1. Go By Point looking north

While at Go By Point, the pilot took several photographs. In two photographs, he captured the navy vessel Her Majesty's Canadian Ship (HMCS) *Goose Bay* approaching the entrance to Mortier Bay. The photographs showed sunny conditions, and the sky to the west, south, and east was clear with unrestricted visibility. The last photograph was of HMCS *Goose Bay* adjacent to Go By Point as it sailed north into Mortier Bay for Marystown. The ship was at this position at 1526. At 1530, security cameras, located at Cow Head, 3.5 nm north of Go By Point on the northern shore of Mortier Bay, showed a heavy snow shower underway. The security cameras recorded uninterrupted snowfall from 1530 until 1630, with intermittent periods of heavy snow and reduced visibility. HMCS *Goose Bay* encountered worsening weather during its transit into Marystown: from sunny and clear at Go By Point to overcast with visibility reduced at times to 100 yards in snow squalls.

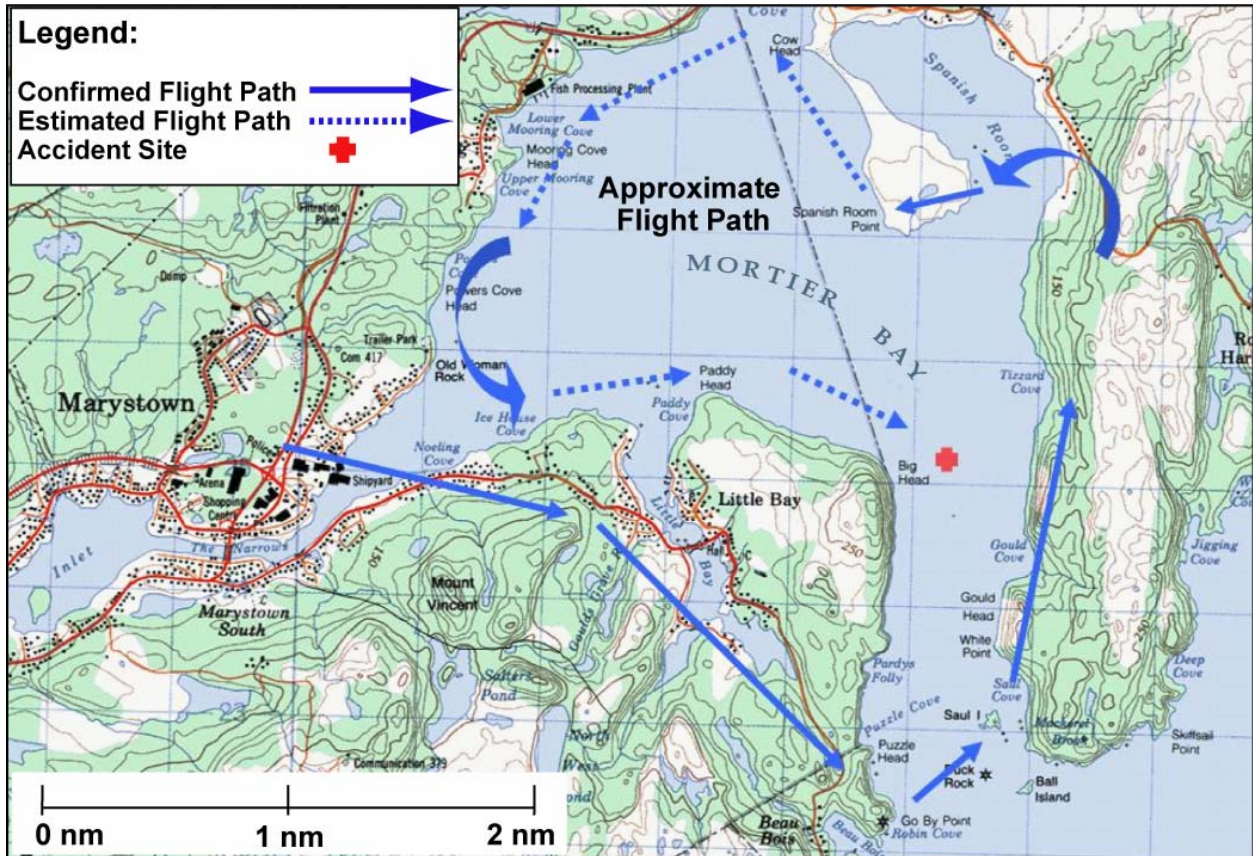
Appendix A – Helicopter Routing

When the helicopter departed Go By Point to return to Marystown, only light snow was falling. It appears that the weather conditions prevented a direct flight to Marystown and that the pilot chose to fly the slightly longer route around the northern perimeter of Mortier Bay (see Appendix A). However, the helicopter would have gradually encountered heavier snowfall as it flew north and then west over the coast towards Marystown. Once established on a westerly heading towards Marystown, it would have been difficult to turn around when severely reduced visibility was encountered because a turn to the right would have required flight into rapidly rising terrain with a possibility of encountering whiteout conditions. A turn to the left would have placed the helicopter out over the water and caused the pilot to lose visual contact with the coast.
